Manhole Inspection Summary

Manhole # S15CC_013MH

Insp Date: **7/30/09 12:09 PM**

Location Address: **1100 CLAYMONT AVE**

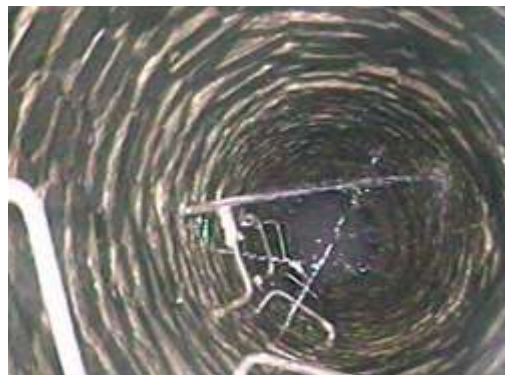
Defect 1

Infiltration: ☐ None ☐ Joint ☒ **Cracks** ☐ Mortar ☐ Roots ☒ **Wall**

Condition: ☐ Sound ☐ Cracked ☐ Root Intrusion ☒ **Deteriorated** ☐ Leaks ☒ **Debris**

MASSIVE INFILTRATION / GUSHER- IN
BARREL, NUMEROUS POINTS, BENCH
DETERIORATED

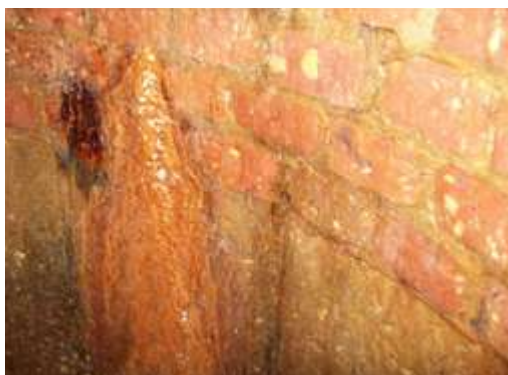
Defect 4

INFILTRATION ON BARRELWALL

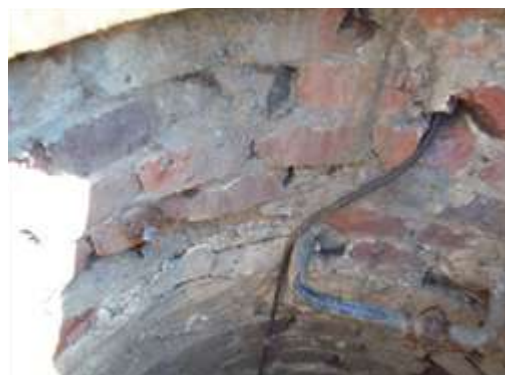
Defect 3

Condition: ☐ Sound ☐ Cracked ☐ Root Intrusion ☐ Loose Brick ☒ **Deteriorated**

DETERIORATED CORBEL

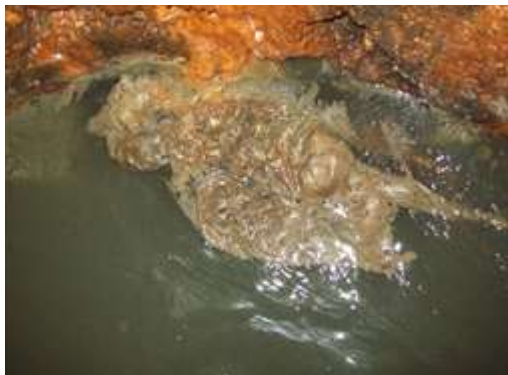
Defect 2

DEBRIS ON BENCH AND CHANNEL

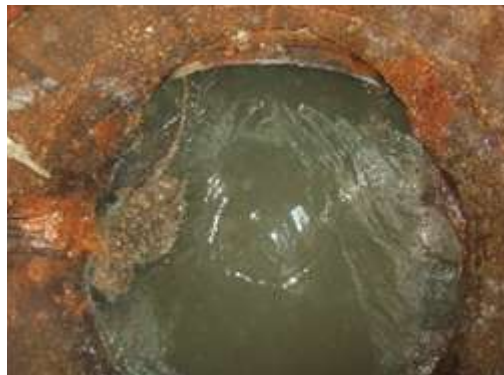
Defect 5

☒ **Evidence Of Surcharge** Depth: **5** (ft.) ☒ **Active Surcharge Present**

ASUR NOW AND SURCHARGE
EVIDENCE

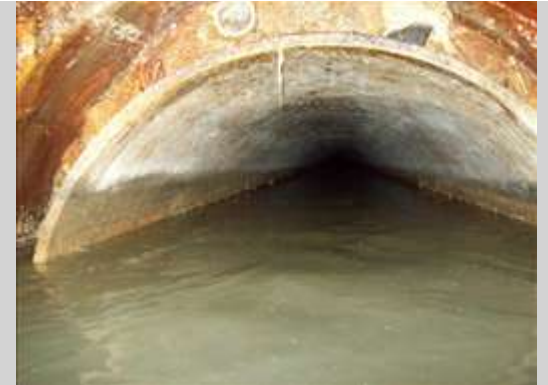
12 O'Clock Outflow

Pipe Height: (in.) Direct
Pipe Material: **Unknown** ☐ Pipe Lined
Invert Depth: **30.80** (ft.) Flow Characteristics: **Slow**
Deposits: ☐ None ☐ Mud ☐ Sludge ☒ **Debris** ☐ Grease
Silt Depth: **8** (in.) Deposits Extent: **Medium**
Infiltration: **Weeper** Pipe Seal Cond: **Cracked**

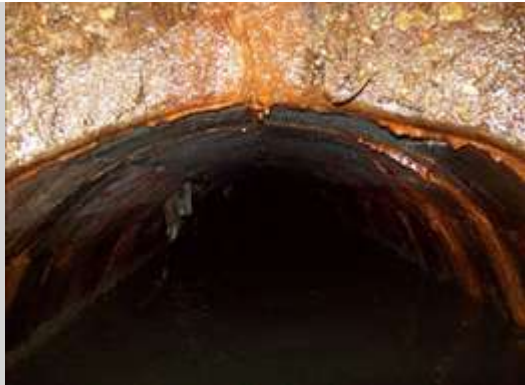
6 O'Clock Inflow

Deposits: ☐ None ☐ Mud ☐ Sludge ☒ **Debris** ☐ Grease

Silt Depth: **8** (in.) Deposits Extent: **Medium**

Infiltration: **Weeper** Pipe Seal Cond: **Cracked**
